Dymet Case Studies: Oil and Gas Industry

Thread Protection of Drilling Pipes

Clearance Restoration in Gas Turbine Compressors

Repair Of Power Cylinder Components Of Gas-Engine Compressor

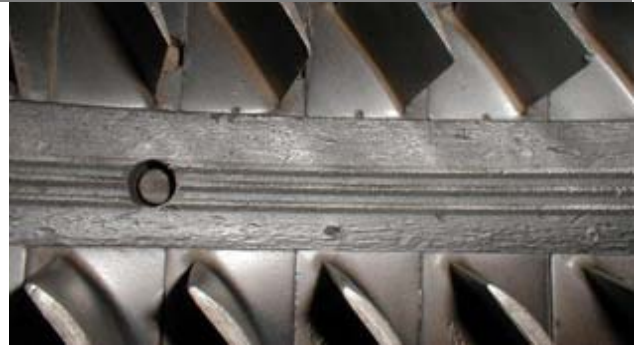
After 6700 hours the required clearance is still maintained. The stator material is cast iron, coating – aluminium.

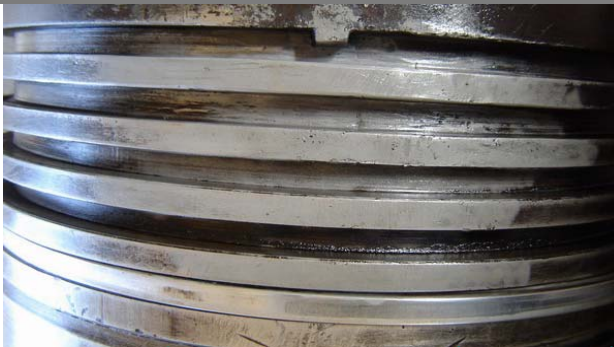
Plunger of power cylinder (D=435mm) had microcracks and worn volume. It was restored with Dymet and grinded. Then a nickel coating was deposited to level the surface, reduce thermal stresses and protect the repaired areas.

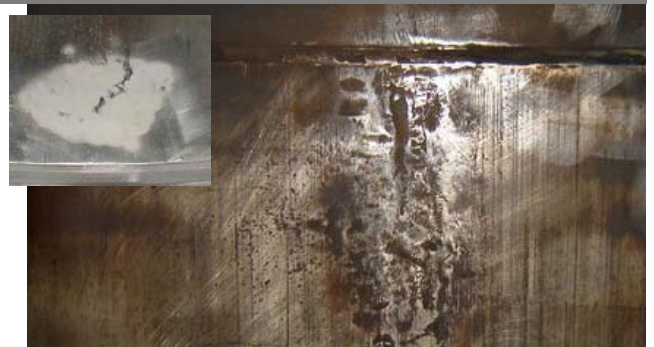
Bush of power cylinder (D=435mm) had a burn-out crack. After abrasive blasting a nickel coating was deposited and then machined to the required size. By now the bush has worked 2500 hours without failure
